Deer Lake Dam. NDI Number PA-00834.  
DER Number 54-112. Delaware River Basin.  
Schuylkill County, Pennsylvania.  
Phase I Inspection Report.

PHASE I REPORT  
NATIONAL DAM INSPECTION PROGRAM

Name of Dam: DEER LAKE DAM  
State & State No: PENNSYLVANIA, 54-112  
County: SCHUYLKILL  
Stream: PINE CREEK  
Date of Inspection: MAY 9, 1979

PHASE I INSPECTION REPORT  
NATIONAL DAM INSPECTION PROGRAM

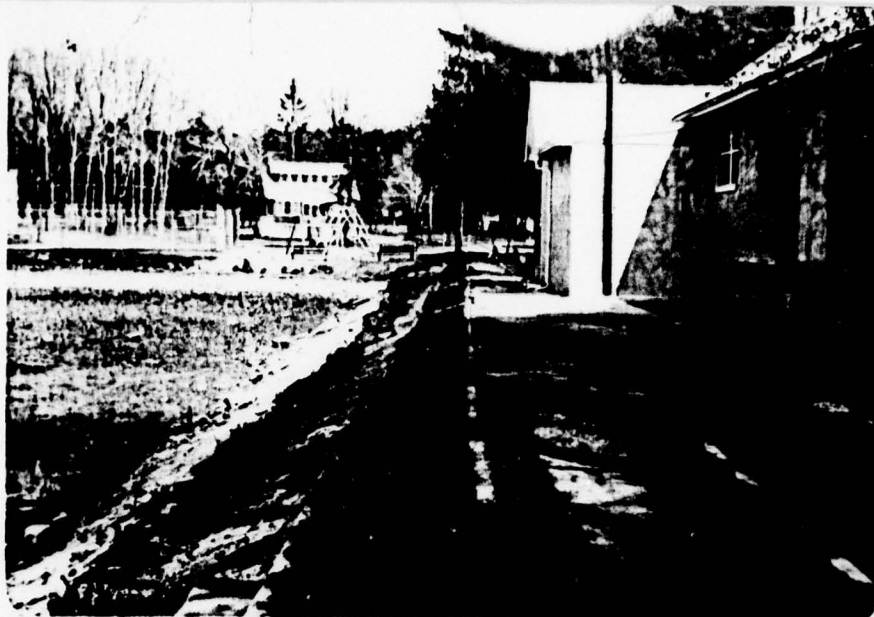
Left End of  
Embankment  
With Fire House

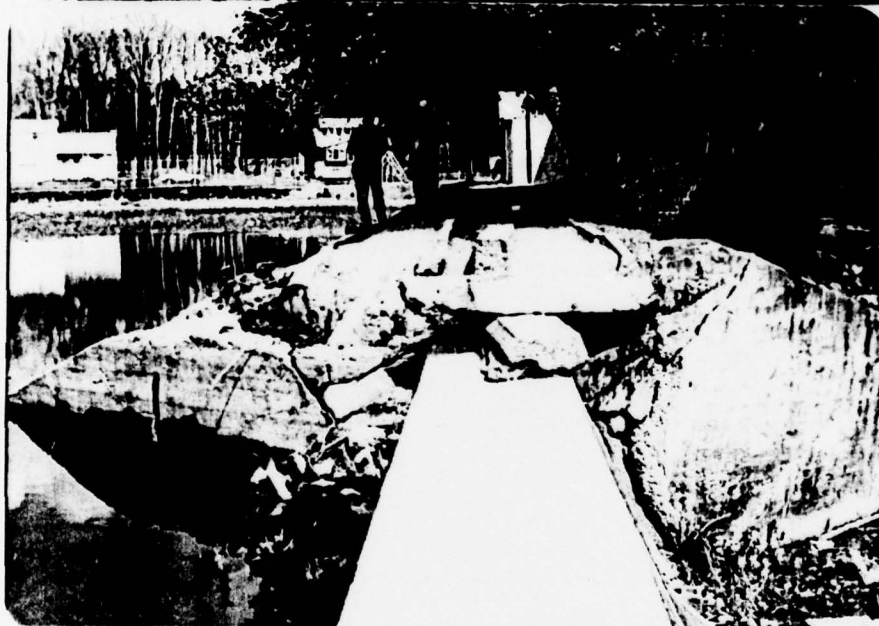
A review of the spillway section indicates an adequately designed section for stability and sliding. The details of the wingwalls are limited. It appears that they were constructed without reinforcing steel. The existing failure of these walls indicates that the design and construction was inadequate. The downstream apron is still in reasonably good condition and undermining was not evident.

Left Spillway  
Abutment Wall

The box culvert near the left abutment has to be repaired or the embankment should be restored to its original condition. The spillway abutment walls should be repaired and properly backfilled.

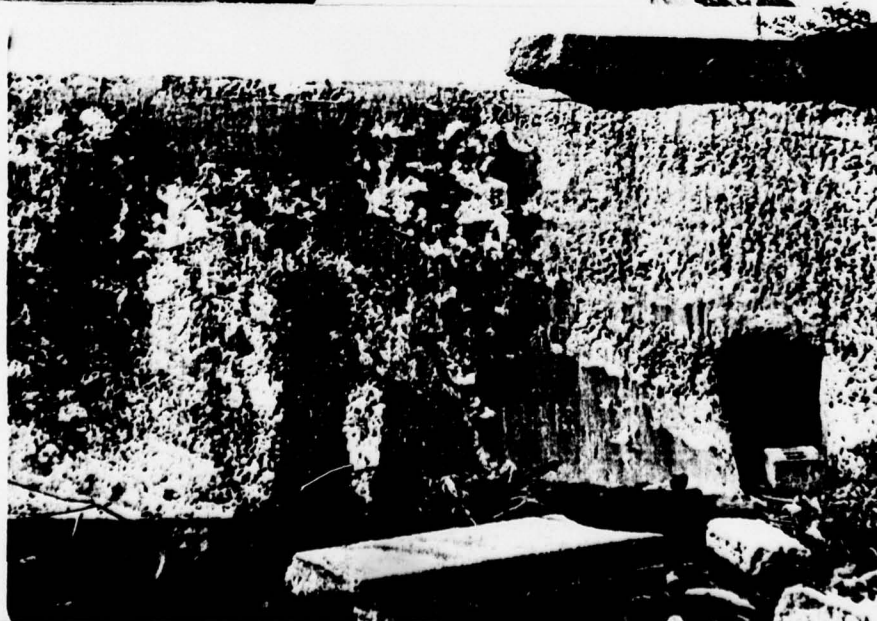
The 245 foot long spillway is a gravity type broadcrested weir. This weir was topped at the time of construction with an 8-inch high corbel to increase the normal pool depth. Most of this corbel has been dislodged from the top of the weir (see photographs). The gravity section and downstream apron are in reasonably good shape, although some deterioration has occurred. Some seepage is coming through the concrete spillway (See Appendix E, Plate E-I).

Downstream Side  
of Spillway  
At Left Abutment

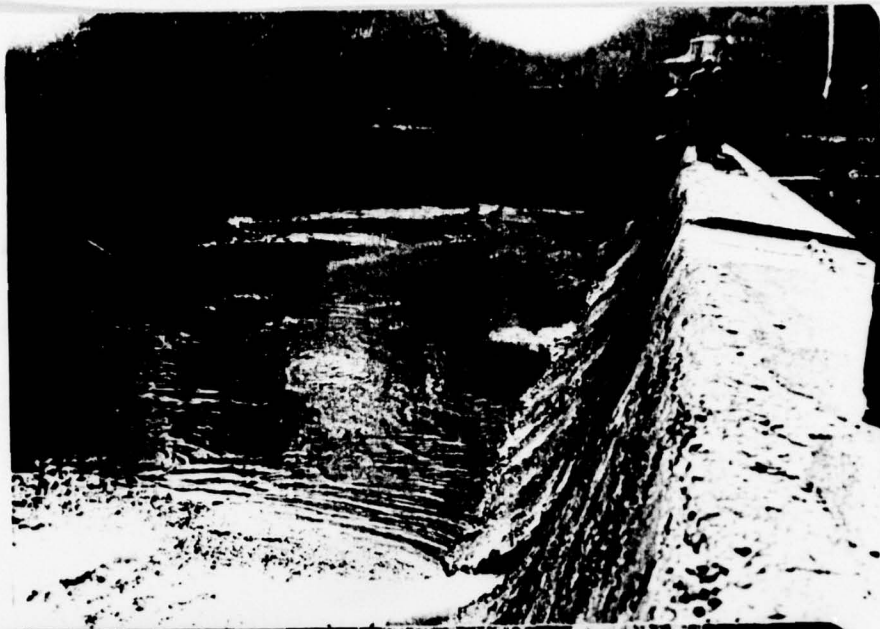
Spillway Towards  
Right Abutment

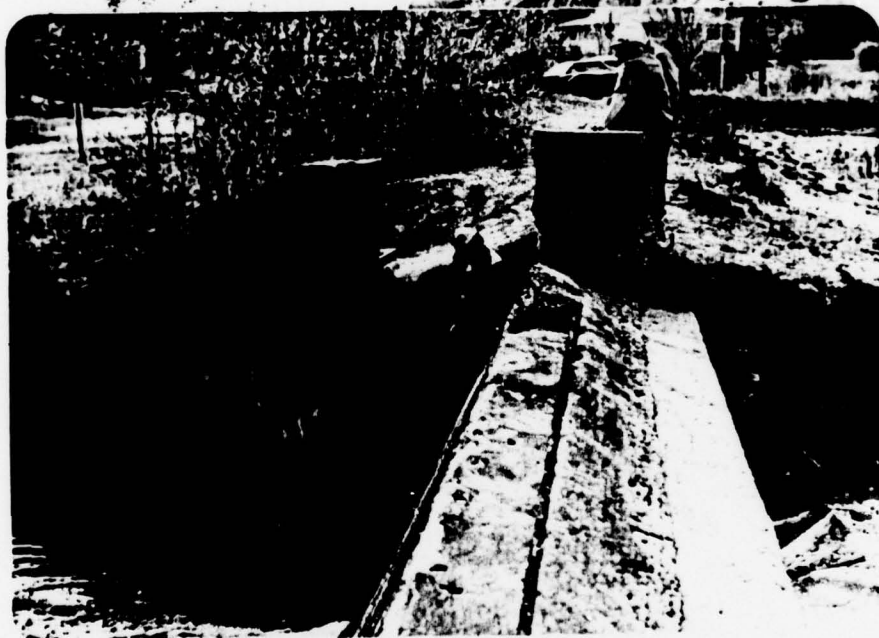
Right Spillway  
Wall

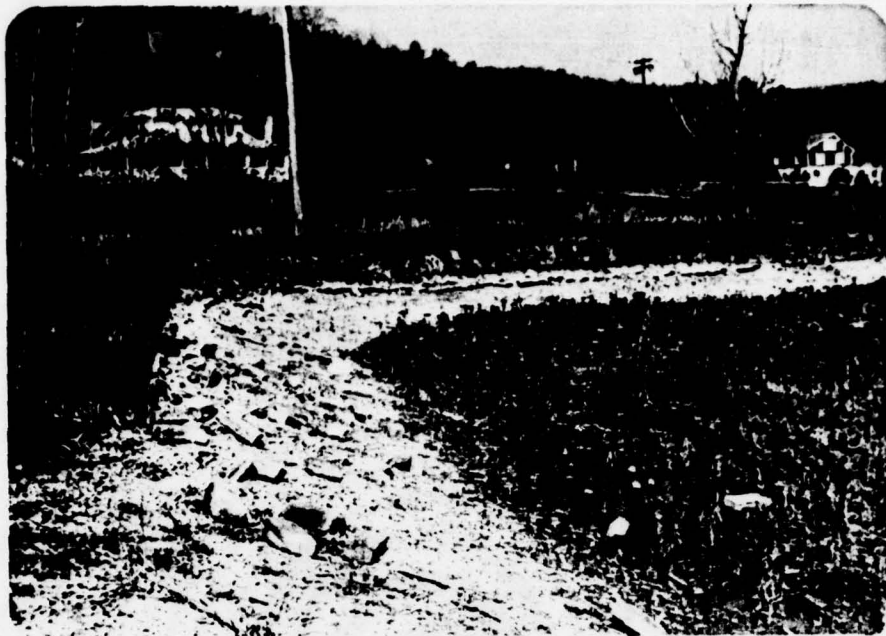
Detail of Upstream Slope at Right End

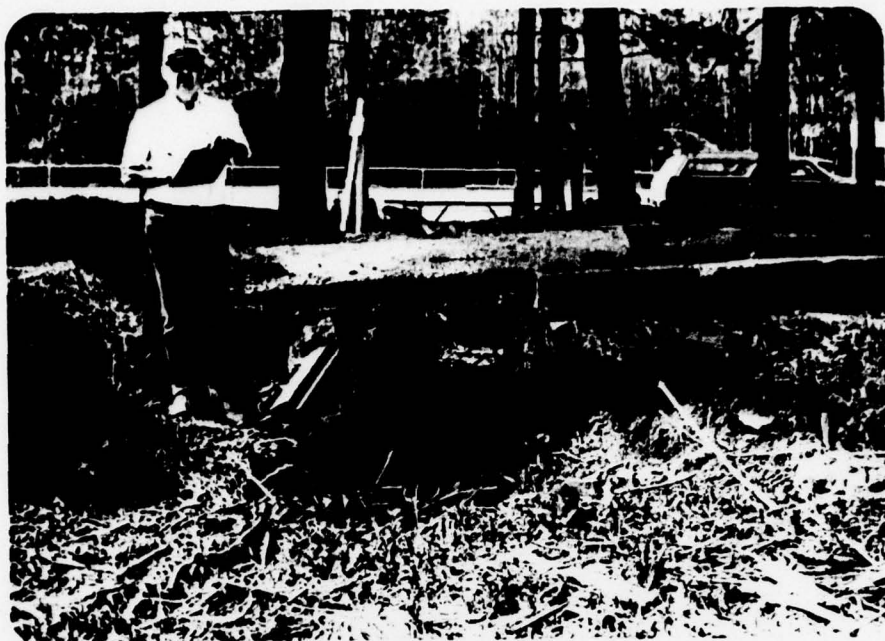
The box culvert near the left abutment was added in the 1950's. The total disintegration of this structure indicates that the design and detailing of this culvert was inadequate. It probably was supported on the concrete core wall and provisions were not made to prevent undermining of the slabs at the downstream and upstream ends.

Outlet Structure  
Left End of Embankment
